INDOOR AIR QUALITY REASSESSMENT

**Hanover Middle School
Hanover School District
45 Whiting Street
Hanover, Massachusetts**

Prepared by:
Massachusetts Department of Public Health
Bureau of Environmental Health Assessment
July, 2002

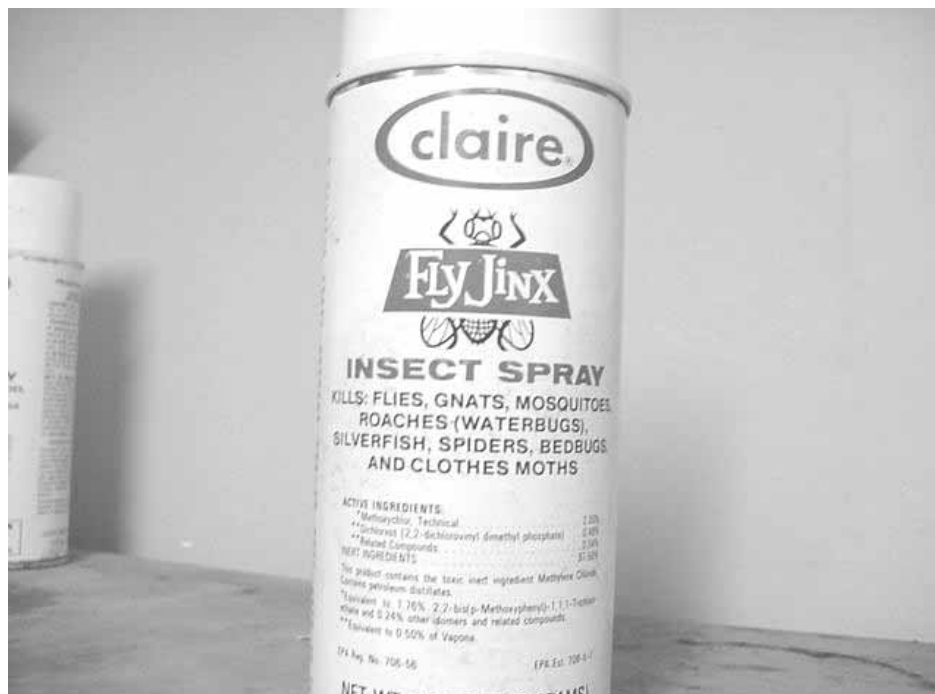
Picture 1

An insecticide, labeled “Fly Jinx”, was found on a table in room J-6 (see Picture 1). The product contains methoxychlor (organo-chlorine insecticide) which is a restricted use pesticide under state and federal law. Only individuals with a restricted pesticide applicator license can apply this product. Insecticides contain chemicals that can be irritating to the eyes, nose and throat. Under current Massachusetts law effective November 1, 2001, the principles of integrated pest management (IPM) must be used to remove pests in schools (Mass Act, 2000). In addition, applicators of pesticides should be in full compliance with federal and state rules and

regulations that govern pesticide use, including posting and notification requirements (333 CMR 13.10). Under no circumstances should pest-controlling products be applied by untrained personnel. Such products should not be applied prior to or during school hours. A copy of the IPM guide is attached as [Appendix IV](#).

Pesticide in Classroom J-6

5. Remove the pesticide container from classroom J-6. It is highly recommended that the principles of integrated pest management (IPM) be used to rid this building of pests. A copy of the IPM recommendations are included with this report as Appendix IV (MDFA, 1996).

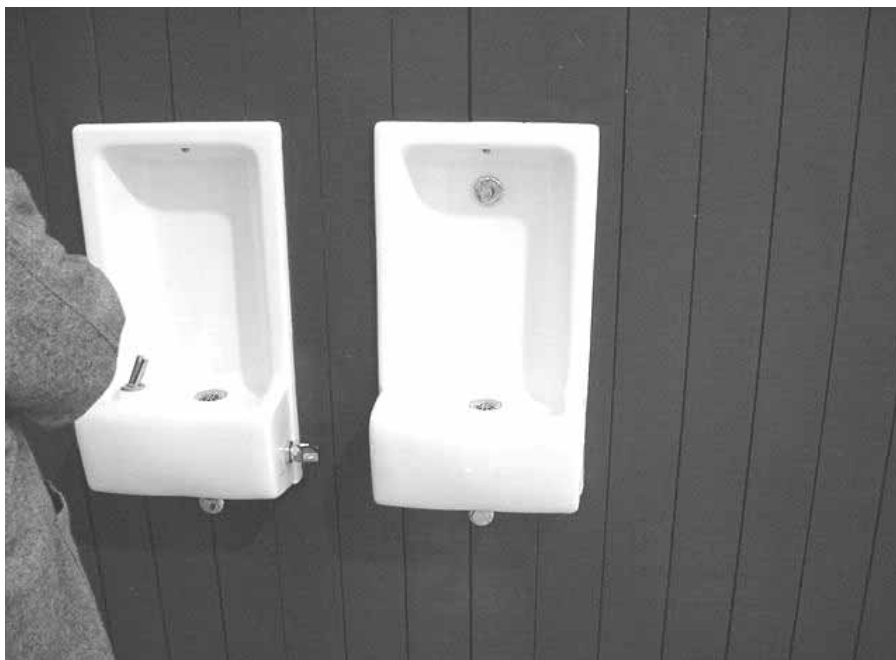
Picture 4

The gymnasium has an unused water bubbler (see Picture 4). It appeared that no water had been poured into these drains recently. Without draining water, the drain traps can dry, resulting in the loss of the airtight seal created by a wet trap. A dry trap can result in sewer gas backing up into the building under certain circumstances. Sewer gas can be irritating to the eyes, nose and throat. The science classrooms have floor mounted emergency eye wash stations (see

Unused Bubbler in Gymnasium

11. Seal openings in suspended ceiling to prevent dust and odor penetration into occupied areas.
12. Seal the dryer vent in classroom 224.
13. Run water into the drain of the unused water bubbler in the gymnasium to prevent drying of drain traps. If these sinks are not to be used, seal drains and disconnect water supply.
14. Clean chalkboards and chalk trays regularly to prevent the build-up of excessive chalk dust.
15. Place a plastic/rubber mat beneath the water cooler to prevent water damage to carpeting.
16. Determine whether eye wash units are connected to the plumbing drain system. If connected, seal pipe opening and pour water into pipe to maintain trap seal.
17. Discontinue the use of tennis balls on chairs to prevent latex dust generation.
18. Consider installing local exhaust ventilation in room 218C to vent photocopiers.

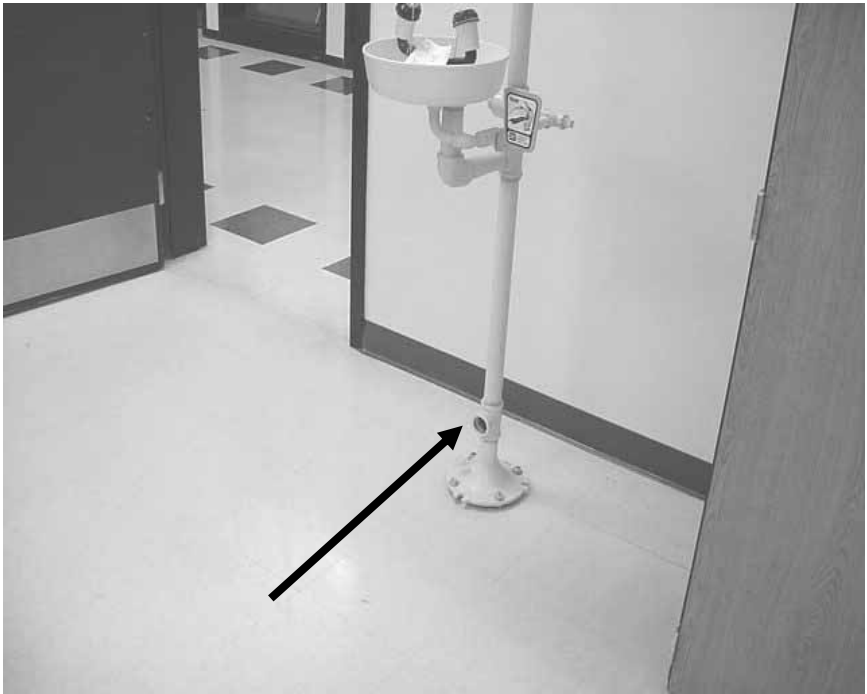
Picture 5

Picture 5). The drainpipe in the base of the station appears to be open to the classroom and when activated, water is allowed to pour from the drain onto the floor. It could not be determined whether these units are connected to the plumbing system. If these eye wash stations are connected to the drainage system, it is also possible for sewer gas to migrate into classrooms through these openings.

Hole In Eyewash Station Drain

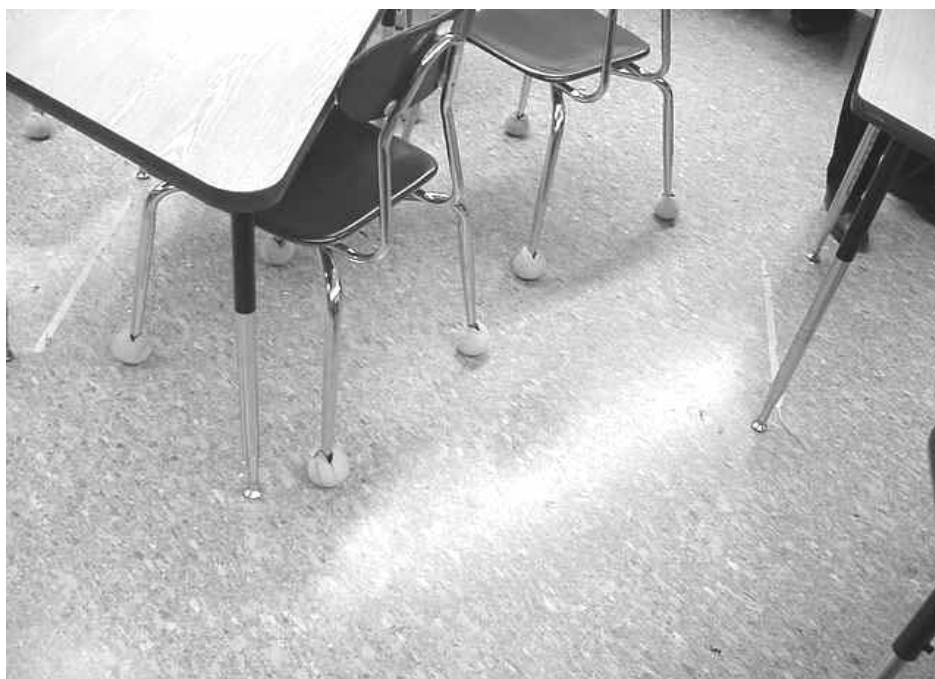
Picture 6

In an effort to reduce noise from sliding chairs, tennis balls are sliced open and placed on chair legs (see Picture 6). Tennis balls are made of a number of materials that are a source of respiratory irritants. Constant wearing of tennis balls can produce fibers and off-gassing VOCs. Tennis balls are made with a natural rubber latex bladder, which becomes abraded when used as a chair leg pad. Use of tennis balls in this manner may introduce latex dust into the school environment. Some individuals are highly allergic to latex (e.g., spina bifida patients) (SBAA, 2001). It is recommended that the use of materials containing latex be limited in buildings to reduce the likelihood of symptoms in sensitive individuals (NIOSH, 1997). A question and answer sheet concerning latex allergy is attached as [Appendix V](#) (NIOSH, 1998).

Tennis Balls On Chairs

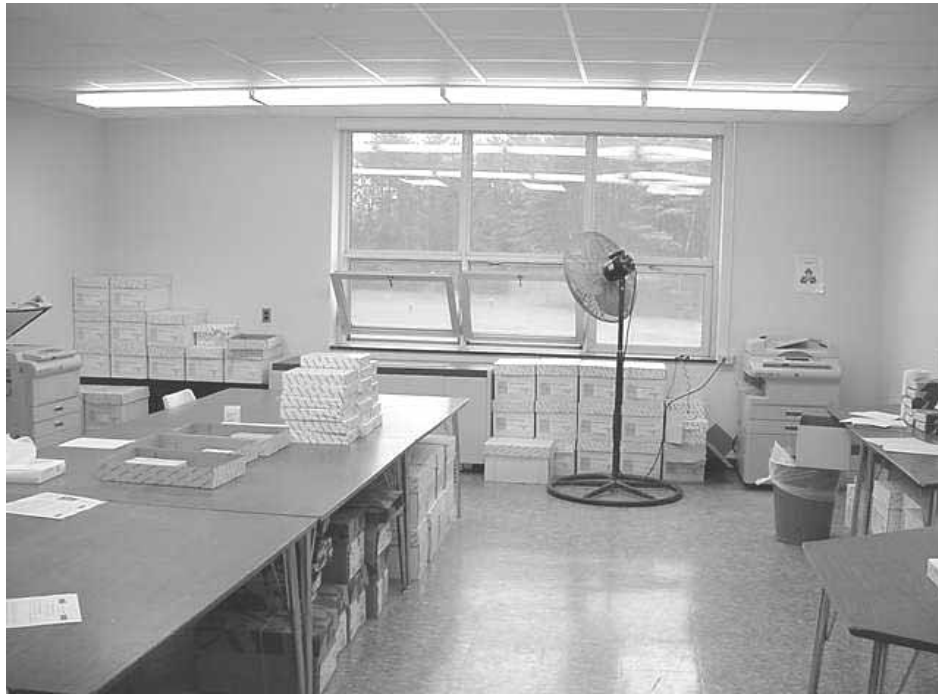
Picture 7

Finally, photocopiers had been moved to room 218C. This area was not equipped with local exhaust ventilation to help remove excess heat and odors. In an effort to provide exhaust ventilation, a free standing floor fan is placed near open windows (see Picture 7). VOCs and ozone can be produced by photocopiers, particularly if the equipment is older and in frequent use. Ozone is a respiratory irritant (Schmidt Etkin, D., 1992).

Fan Used To Provide Exhaust Ventilation for Photocopiers
